Manhole Inspection Summary

Manhole # S06AA2013MH

Location Address: **3801 FALLSTAFF RD**

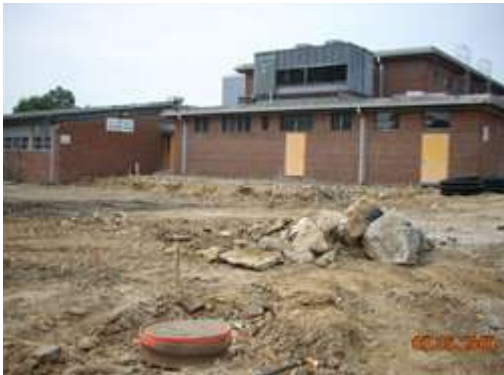
Location View

Comments **The MH area (a school) is under constrction. The MH frame and lid are damaged and the pipes are filled in with mud. Only able to get an O12 pipe pic. 08/05/08**
